Visual simulation of Home Depot in Burlington, WA during a major flood event (the FEMA 100-year flood). Floodwaters are estimated to rise 4.8 feet above ground elevation at this site.

Visual simulation of Walmart in Mount Vernon, WA during a major flood event (the FEMA 100-year flood). Floodwaters are estimated to rise 10.6 feet above ground elevation at this site.

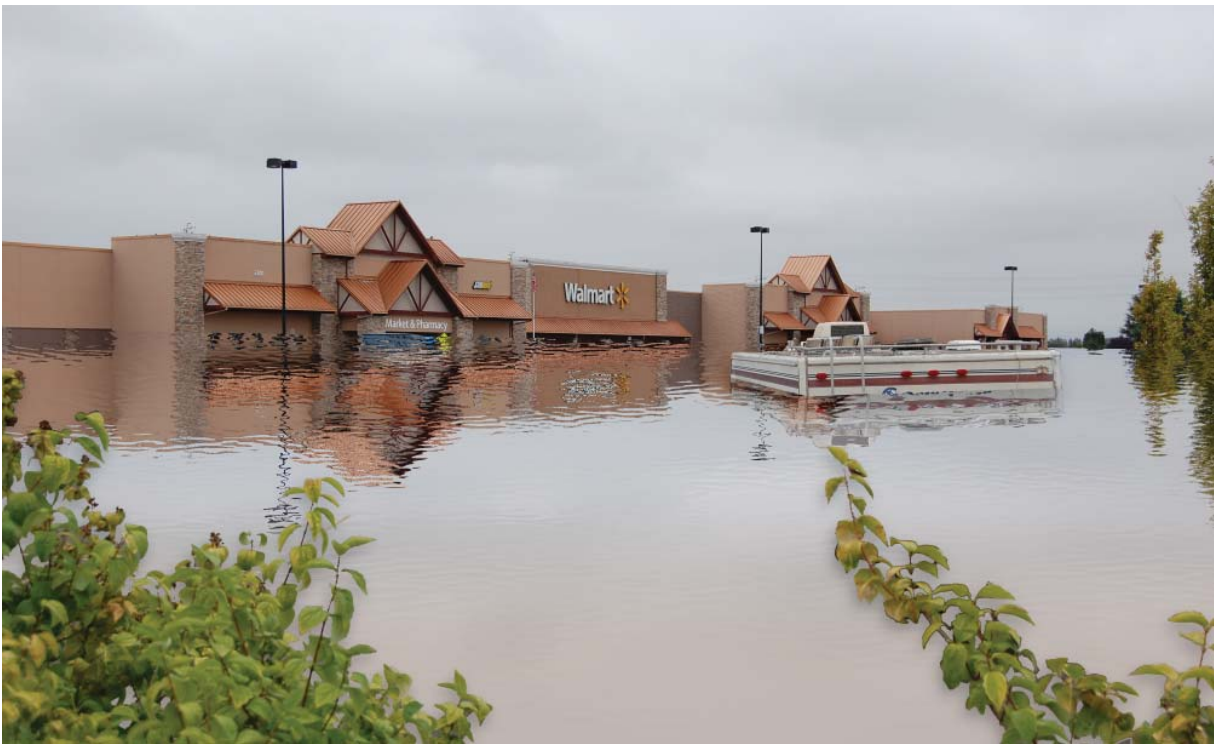
Visual simulation of Walmart in Mount Vernon, WA during a major flood event (the FEMA 100-year flood). Floodwaters are estimated to rise 10.6 feet above ground elevation at this site.
